# Manhole Inspection Summary

# Manhole # S55U\_\_006MH

Insp Date: **7/9/08 11:18 AM**

**Location** Address: **1701 s. clinton st.**

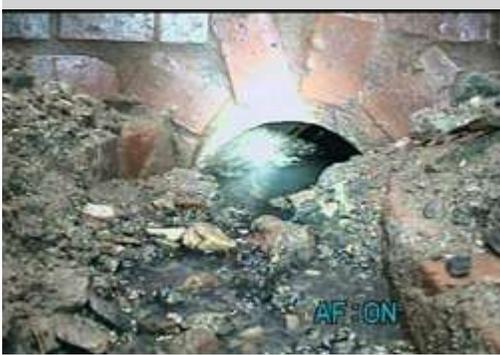
Defect 5

Condition:  Sound  Cracked  Root Intrusion  Deteriorated  Leaks  **Debris**

channel debris

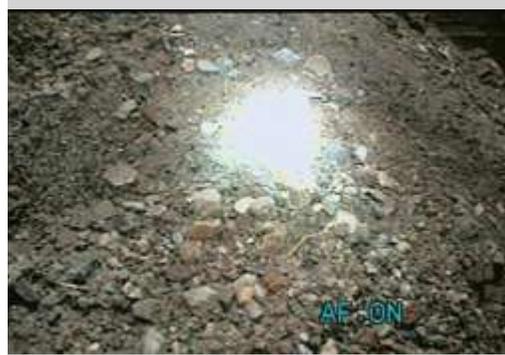
Defect 4

Condition:  Sound  Cracked  Root Intrusion  Deteriorated  Leaks  **Debris**

bench debris

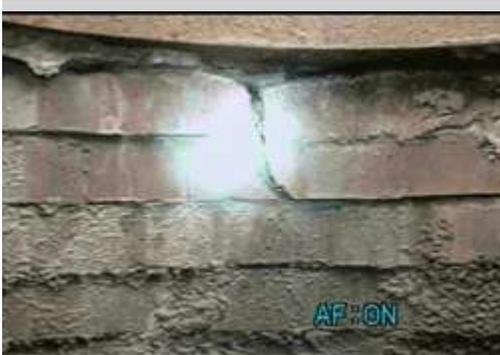
Defect 3

Condition:  Sound  **Cracked**  Root Intrusion  Loose Brick  Deteriorated

corbal

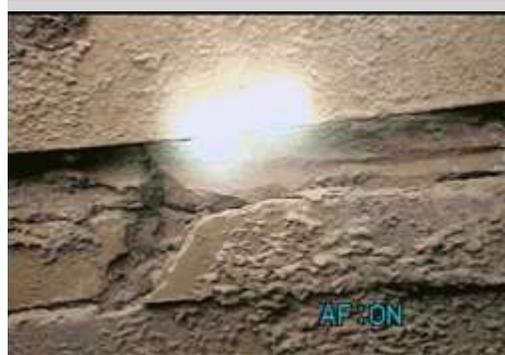
Defect 2

Condition:  Sound  **Cracked**  Root Intrusion  Loose Brick  Deteriorated

chimney cracked

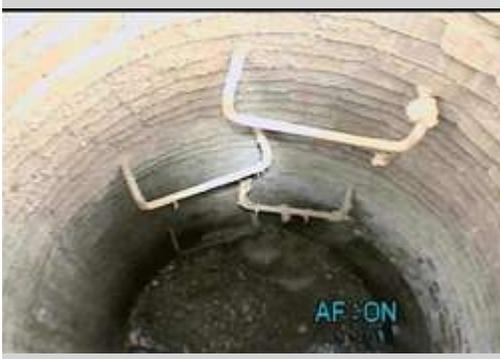
Defect 1

Count: **4** Missing: **0**  **Corroded**

steps

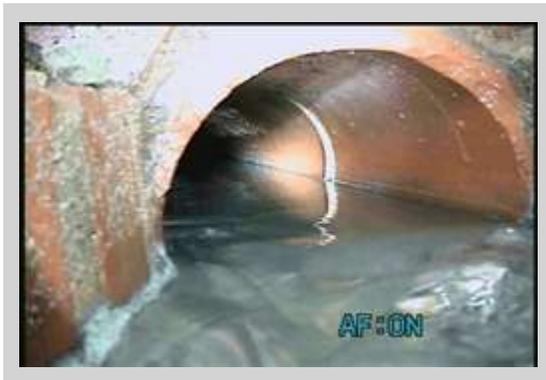
3 O'Clock Inflow

pipe on angle
